Case Study:

Route 40 Culvert - Westford, MA

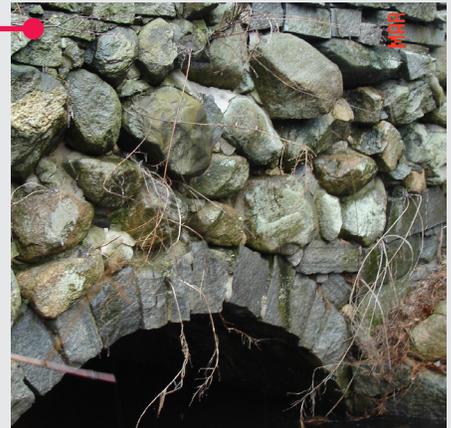
The Keyes Brook culvert, which crosses under Route 40 in Westford, was comprised of a stone arch structure that experienced a partial collapse in 1987. When the collapse happened, a corrugated metal pipe was inserted into the structure to provide additional structural strength, however, over time the bottom of the pipe corroded. It was imperative that the entire culvert be replaced given that nearly 10,000 vehicles travel along Route 40 each day.

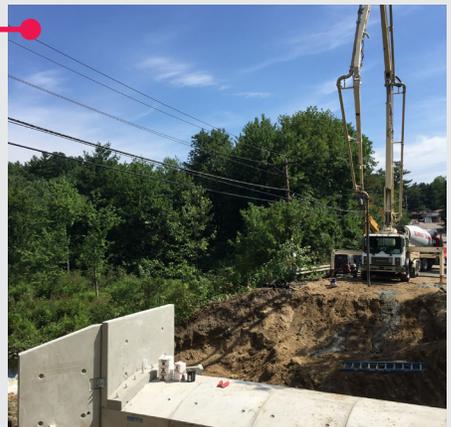
LandTech utilized 3D laser scanning to obtain the exact dimensions of the existing culvert, for use when analyzing the entire watershed, to determine the adequate size of the new culvert. Careful planning and scheduling by the Town enabled the construction to proceed, with the entire road shut down for two weeks, in order to place the new precast structure.
